*Improving Bridge Inspection, Scour Monitoring and Infrastructure Management for DOTs using the Echoscope® - A true 3D, High-Definition and Real-Time imaging tool.*

By Chris Gorman, PE M.ASCE

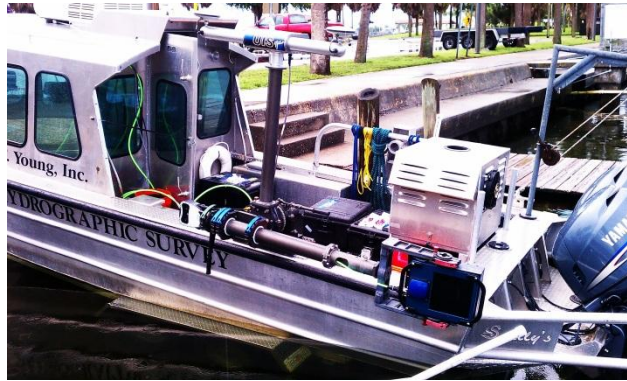
**Figure 1: George F Young preparing to survey structures with the Echoscope®.**

The Echoscope® is typically deployed on a small boat with a suitable attitude and positioning system with position, heading, pitch, roll and heave inputs. Fitting the sonar head to a pole mounted on the vessel's side is the most common method for inspecting bridges and structures at depths up to 175ft below the surface. But for deeper structures the Echoscope® can be mounted on an ROV or AUV or alternatively, it can be mounted on a fixed tripod with an integrated Pan-and-Tilt head to execute a sector-scan method.

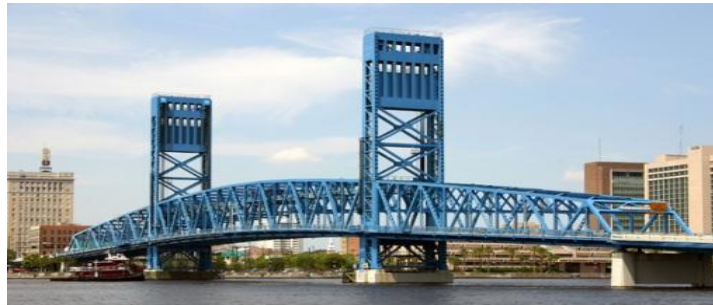
**Figure 3: Main St. Bridge over the St. John’s River in Jacksonville, Florida- Built in 1941.**

Depicted are images of the Main Street /SR90 Bridge in downtown Jacksonville, FL. These scans were completed during a joint training workshop with the USACE – Jacksonville District and the Jacksonville Sheriff’s Office (JSO). These images represent raw data that have not been post-processed or altered.
